Reassessment of Dam Foundation Stability – the Case of Three Swiss Dams

Dr C. Cekerevac¹ and A. Wohnlich²

^{1,2} STUCKY Ltd, Rue du Lac 33, P.O. Box, CH – 1020 Renens VD1, Switzerland

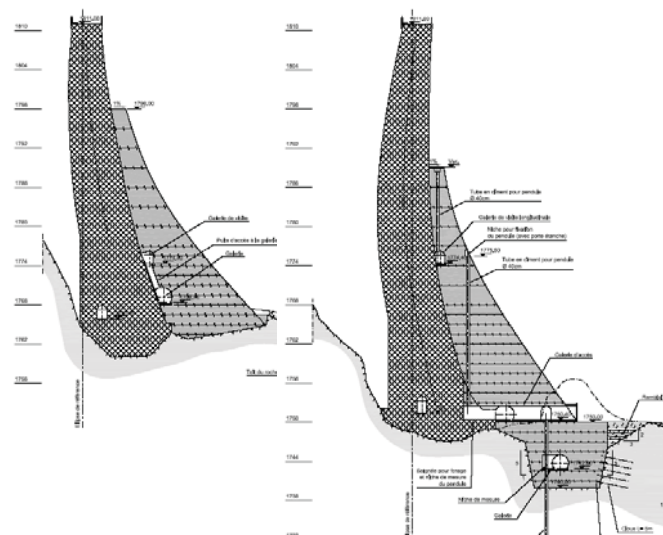
Figure 1: Rehabilitation of Les Toules arch dam, Downstream elevation, Strengthening project shown in grey

The dam foundation lies on gneiss and mica schist rocks, forming alternate subvertical strips almost parallel to the valley. The gneiss appears to have better mechanical properties and to be more rigid than the mica schist; thus the dam rests on an alternate series of rock formations which have variable properties and stiffness, especially on the left bank (Figure 1).

Figure 1 shows the dam elevation from downstream, where the strengthening is highlighted in grey. Figure 2 shows the typical cross-section of the dam with the strengthening (left), whilst the particular case of bloc No. 6, which is further explained below, is shown on the right hand side.

- A unique downstream strengthening in a form of abutment thickening (concrete volume around 60'000 m³), transferring the load from over-loaded cantilevers to the thickened arches;
- The creation of shear keys in the vertical joints;
- Local foundation treatment, in particular on the left bank at dam bloc No. 6, which is founded into the weakest rock formation of the site (mica schist);
- And some other minor rehabilitation or improvement works.

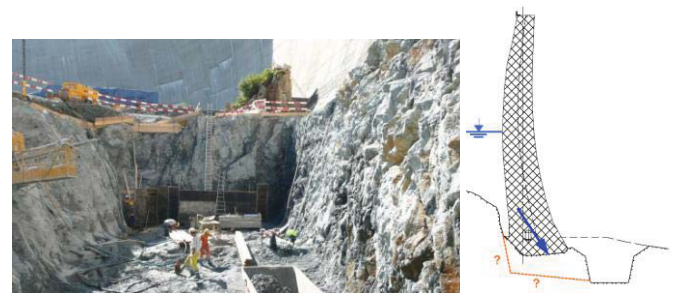
Figure 3: Rehabilitation of Les Toules arch dam, Bloc 6, Excavation of the local deepening of the strengthening

On this basis, the dam foundation stability conditions have been assessed, and found barely acceptable if not below the standards published by the Federal Office of Energy (FOE), in charge of dam safety in Switzerland [3, 4]. This was especially true for the extreme loading case (earthquake) on the left bank by bloc No. 6, where the dam is founded into mica schist rock featuring the weakest rock mechanics parameters of the whole dam site.

Then the stability conditions were checked with the consideration of the rehabilitation solution. Due to the particularly poor conditions of the rock foundation of bloc No. 6, the strengthening had locally to be deepened by some 10 m to found the dam further down into the rock mass (Figure 2, right) and reach regular safety conditions.

Of particular interest is the execution of the local deepening of the strengthening foundation. The excavation was carried out by blasting, complying with very stringent requirements in terms of allowable wave velocity (12 mm/s). Such requirement was imposed by the upstream proximity of the arch dam. It is also worth noting that for safety reasons during the rehabilitation works, the reservoir water level is lowered by 30 m. Figure 3 shows a picture of the local deepening of the foundation (left), while the critical cross-section of bloc No. 6 after excavation is presented on the right. Although such unusual dam section with a hole right downstream was temporary (for some weeks only, until the strengthening is concreted and the hole filled up again), a particular attention was given in the design of this temporary loading case, and during the job site supervision. The realization of this delicate job took place in 2008 and occurred without any particular problem.

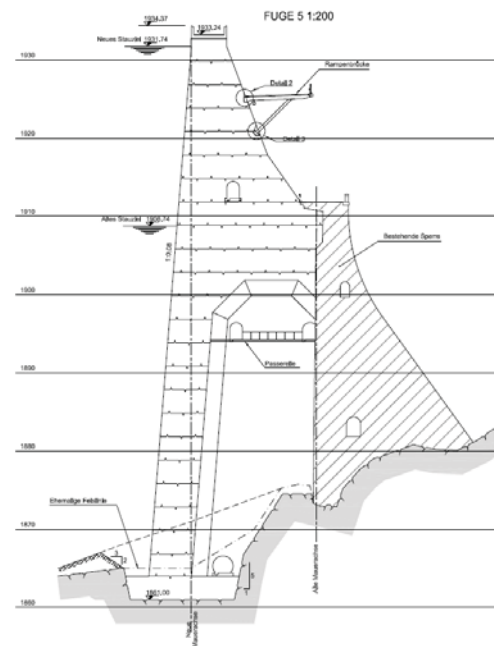
Figure 5: Heightening of Seeuferegg gravity dam, Typical cross-section of the heightened hollow-gravity dam (existing dam on the right, drawn with hatch)

The existing Seeuferegg gravity dam is 42 m high and was built in 1932. To increase the reservoir volume for winter production, the dam is projected to be turned into a hollow gravity dam, the heightening being built against the upstream face of the existing dam inside the reservoir (Figure 5). Due to the reservoir level heightening, the water pressure acting on the dam face will be notably higher than at the existing dam; consequently the uplift pressure developing in the dam foundation will be higher as well. Therefore the dam foundation stability conditions must be carefully assessed and checked. One of the design advantages of turning a gravity dam into a hollow-gravity dam is the reduction of uplift pressure acting in the foundation thanks to the drainage provided by the hollow cavities.

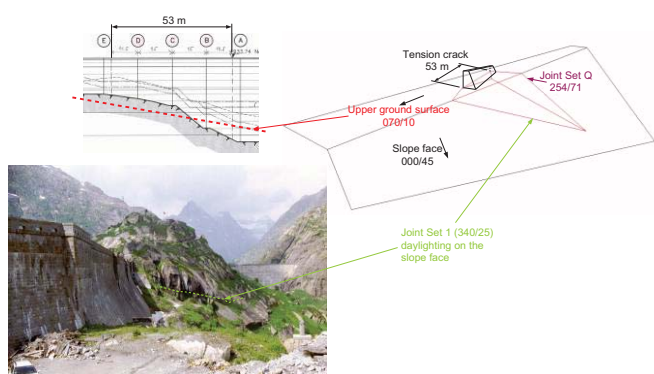
Figure 6: Heightening of Seeuferegg gravity dam, Foundation stability analysis of a critical wedge formed by two existing joint sets

The review of all joint sets observed by the geologist allows identifying a critical combination on the left bank abutment. Figure 6 shows that a tensile crack propagating into the rock mass below the upstream dam face might combine with joint set No. 1 (daylighting on the downstream slope and clearly localized on site) and joint set No. Q, to form a potential hazardous wedge.

Interestingly the wedge defined and presented above is not touched by the existing gravity dam, since it is located on the top of the left bank, above the current dam crest elevation.

First, the wedge stability conditions are checked for the present conditions, and the analysis shows that the extreme loading case (earthquake) is not complied with.

Then, the wedge stability conditions are checked with the heightened dam. The results obtained from the analysis are clear-cut: in no cases the safety requirements are reached, even when the uplift pressure acting on both joint planes is strongly reduced (drainage efficiency). Therefore the implementation of remedial measures to increase the safety factor is necessary.

- Excavation of galleries in the foundations to intercept the joint planes and filling up the galleries with concrete (creation of shear key galleries);
- Implementation of prestressed anchors in the downstream slope to increase the stress acting perpendicular to the critical joint and thus add resistance against sliding;
- Deepening the dam foundation level below the elevation of the critical joints.

A technical and economical analysis of the alternatives shows that the third alternative is the most radical in the sense that it gets rid of the joint presence problem. Both other alternatives endeavour to improve the joint conditions by increasing either the cohesion along the joint (shear key galleries), or the force acting perpendicular to the joint (prestressed anchors). With respect to that, deepening the dam foundation elevation is most probably the most reliable alternative. It is also the most flexible solution to implement, since it can be adapted on the spot to the effective rock conditions faced during excavation.

On this basis, the dam heightening design was adapted in the area of the left bank, going deeper into the rock mass to found the dam below the elevation of the critical joints, and the wedge stability issue was resolved.

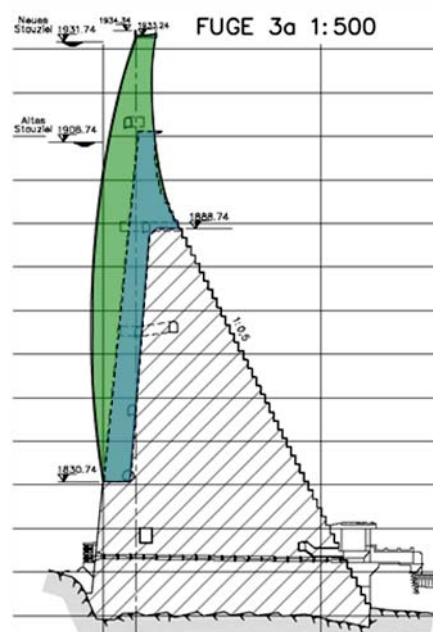
Figure 7: Typical cross-section of Spitallamm arch-gravity dam (in blue: existing dam concrete to be removed; in green: heightening project)

The Spitallamm dam is a 114 m high, single curvature arch-gravity dam, built in 1932. The crest length is 258 m and the concrete volume 340'000 m³. According to the actual project, the dam is heightened by 23 m, in the form of a double curvature structure applied on the upstream face of the existing dam, after removing the existing upstream face which is not in good conditions (Figure 7).

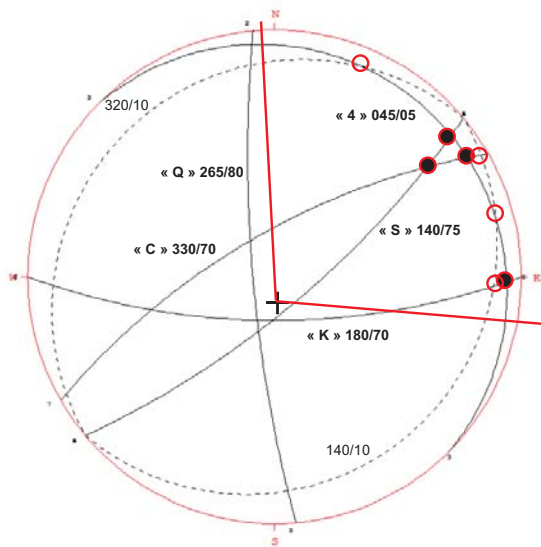
Figure 8: Stereographical projection (lower hemisphere) of the joint sets for Spitalamm dam

Several joint sets were identified on site with some discrepancies between different sources. Combining the available sources, a stereographical plot (low hemisphere projection) of the joint sets and orientation (Nord-East) of Spitalamm dam is prepared (Figure 8). In the same plot, potentially unstable wedges are indicated by a full circle. Potentially unstable wedges are situated in the intersection of joints “K”, “S” and “C” with a horizontal joint “4”. Empty circles show wedges based on joints with lower confidence; they are observed by one source only or by very old geological examinations.
