Deriner Hydropower Scheme – Geotechnical Issues and the Particular Case of the Spillway Tunnels Design and Construction

C. Cekerevac & A. Wohnlich
STUCKY SA, Renens, Switzerland

ABSTRACT: The paper addresses some geotechnical issues related to the construction of the Deriner dam and HEPP. Design considerations and rock stabilization measures are presented for the excavations which took place in a highly fractured and weathered rock mass prevailing on site. Particularly, the shallow excavations for the overflow spillways tunnels are discussed. These present huge openings that are 12 m wide and 18 m high in portal areas, with an overburden of approximately 20 m, for which numerical finite element analysis and structural discontinuity analysis have been performed to ensure safe excavation process and future operation.

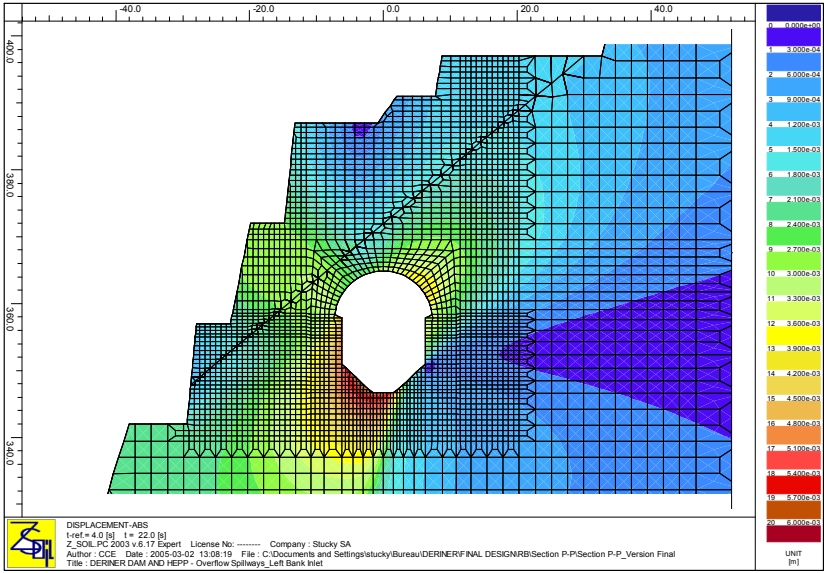
Figure 6: Maximal displacement due to tunnel excavation.

- INP 220 steel ribs, spacing 1.0 m,
- shotcrete 12 cm thick, which is then increased to get a temporary vault 35 cm thick,
- in the walls, the shotcrete is 12 cm thick, and reinforced with wire mesh.
- systematic bolting spaced 1.5 x 1.5 m (2.25 m²/pce), L=5 m. Due to presence of the C-fault (Figure 6) on the valley side of the tunnel length of the rockbolts has been increased to 9 m and spacing 1 x 1 m (Figure 8).

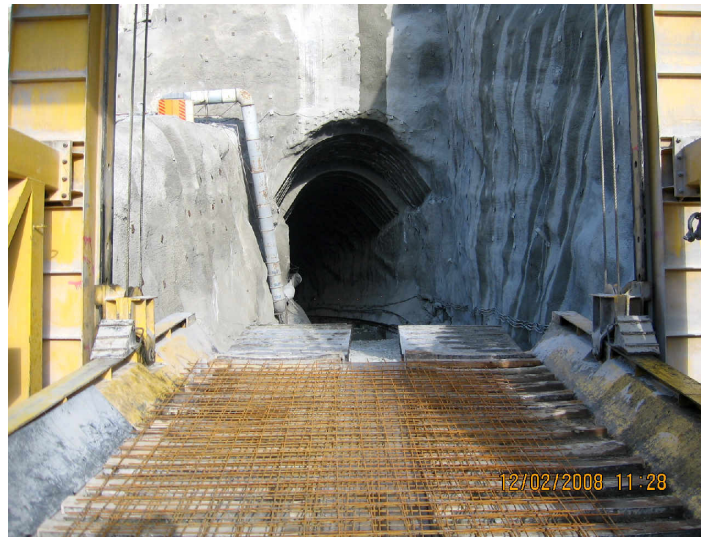
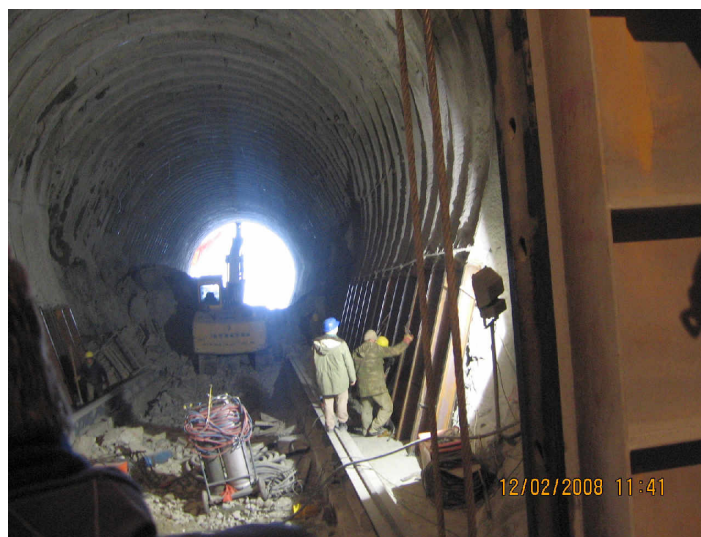
Figure 9. Overflow spillway on the right bank: photos made during construction.

For the purpose of the tunnel excavation, a special winch on rails has been developed, allowing transport of the excavated material. It should be noted that the excavation of the overflow spillway has been successfully carried out (Figure 9) without any stability problem in spite of a quite complex geometry of the tunnel and quite difficult geological conditions.
